VOLUNTARY ACTION EPPING FOREST

HANDYMAN

Case Study - VAEF Handyman Service – Building a Yacht!

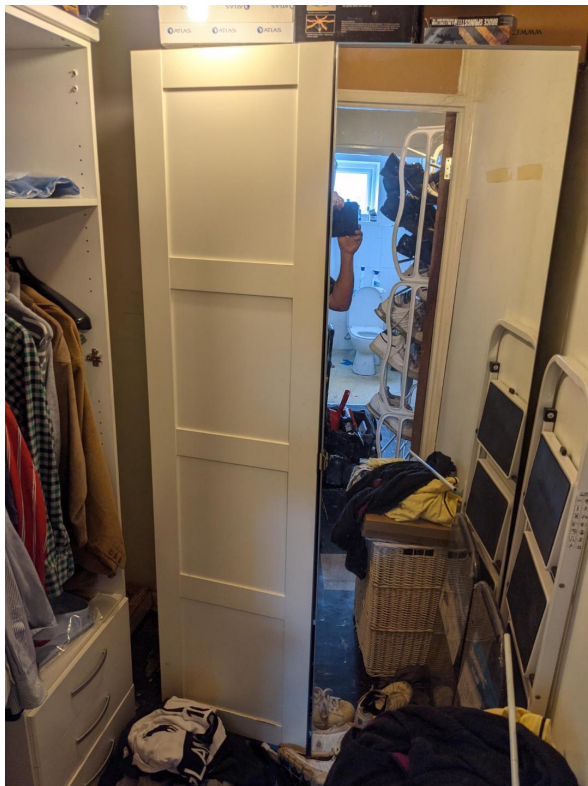
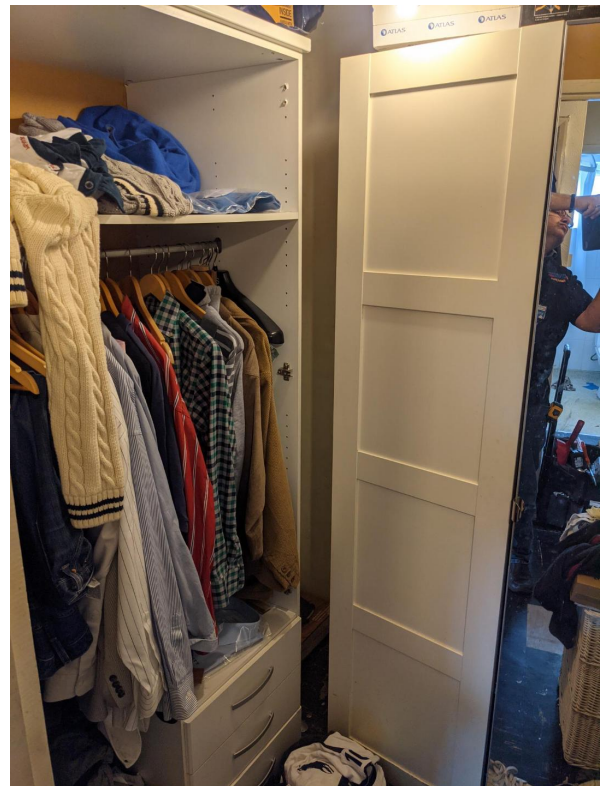
There is a small room approximately 6ft x 6ft which Mr C calls his closet, within it are two wardrobes, piles of boxes and other items such as steps etc. When trying to reach his clothes Mr C becomes obstructed by the wardrobe doors and as a consequence of his struggle his clothes often end up on the floor and he is unable to pick them up and put them back.

This is a small contained room, it was easy to see that the four wardrobe doors were causing access issues and they could easily be removed. Doors could be recycled as shelving. Altering the layout so that the two wardrobes did not face each other giving very little “dressing room” could be undertaken. Space freed up could be used for additional hanging or shelves.

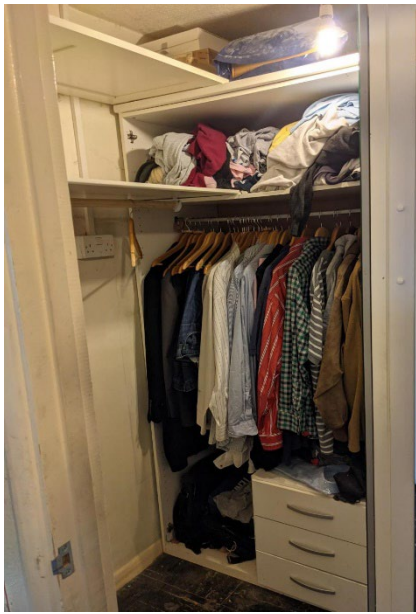
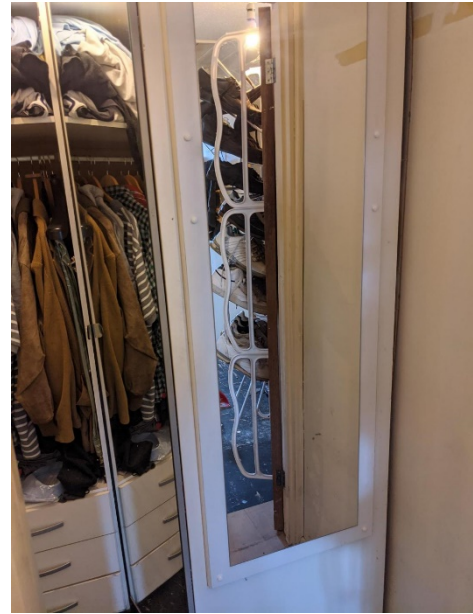
The outcome:

Two doors recycled as shelves, one door with mirror re sited to provide a full length mirror.
Shoes stored in full length rack on the rear of the door providing space and visibility

By recycling the wardrobe doors, the cost was limited to the new rail and fixings which came to less than £4

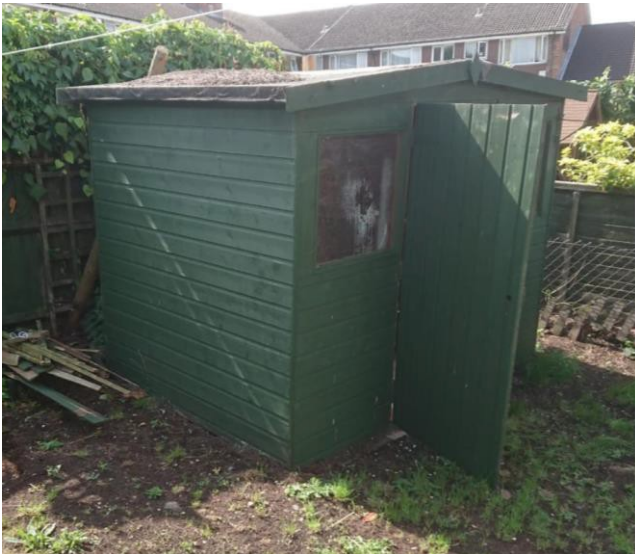
Recently a very large conifer had been removed from the neighbour's garden, the result of which had been some serious disturbance of the garden around the trunk. Mrs F's garden shed was now sitting very unevenly as the paving base had lifted in some areas and sunk in others. The door no longer closed properly and the felt had been damaged rendering the roof porous.

Getting to the uneven base would be a challenge. Fortunately, the shed was almost empty due to the leaks and removing the roof sections was straight forward especially as the felt needed replacing anyway.

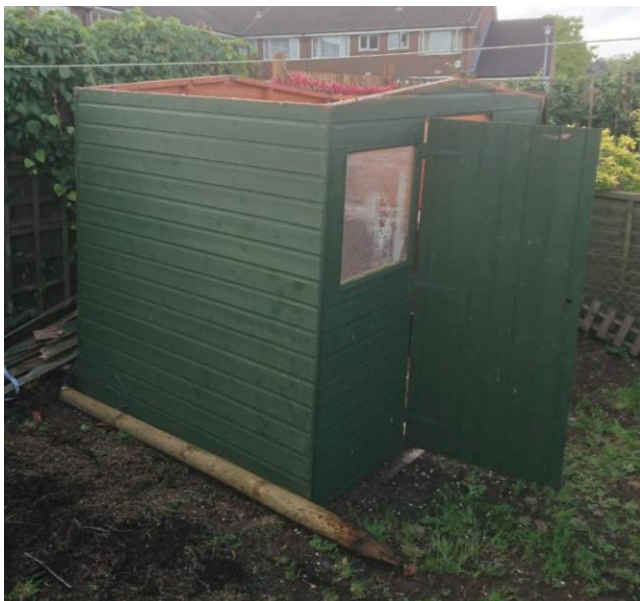
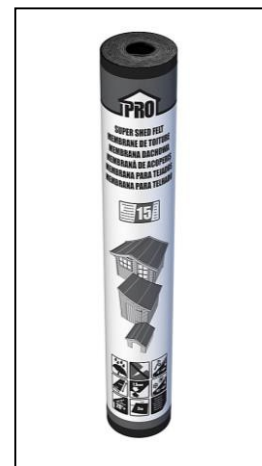
So with the roof removed I used a long round pole as a roller to enable the shed to move – of course it had to be lifted onto the pole first!

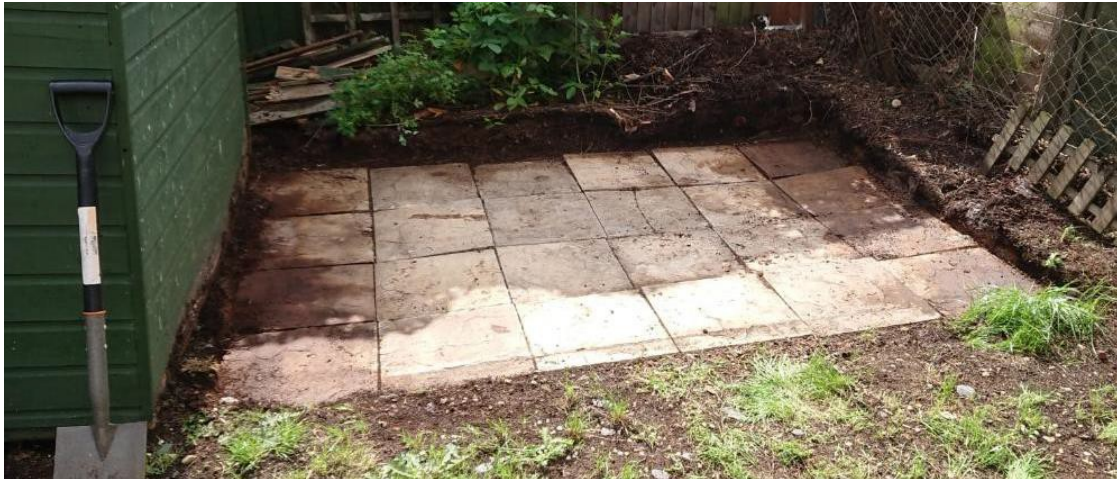
With the shed manhandled across the garden the base was revealed.

Every slab required lifting and re-laying to become level. Roots needed to be chopped out in places and soil cut back to expose the full area.

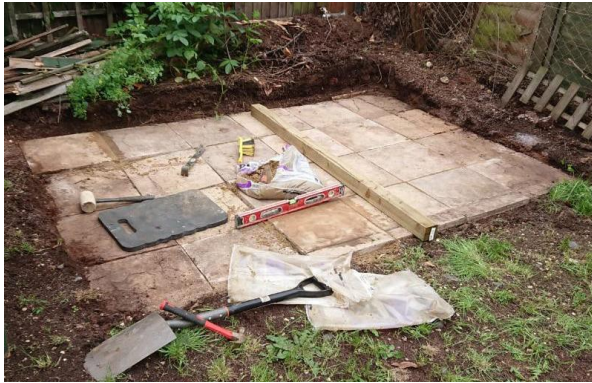
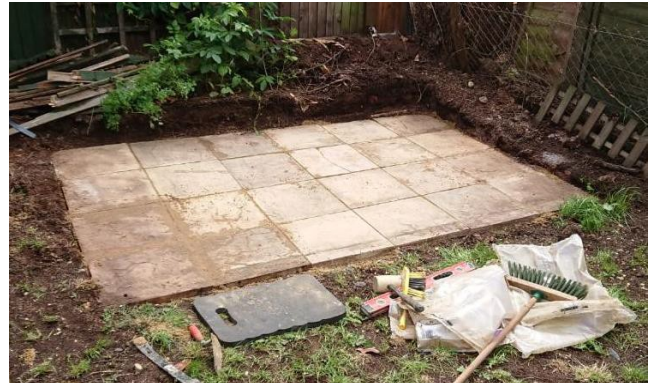
Using the same rolling method, the shed was heaved back onto its new base and the door was rehung.

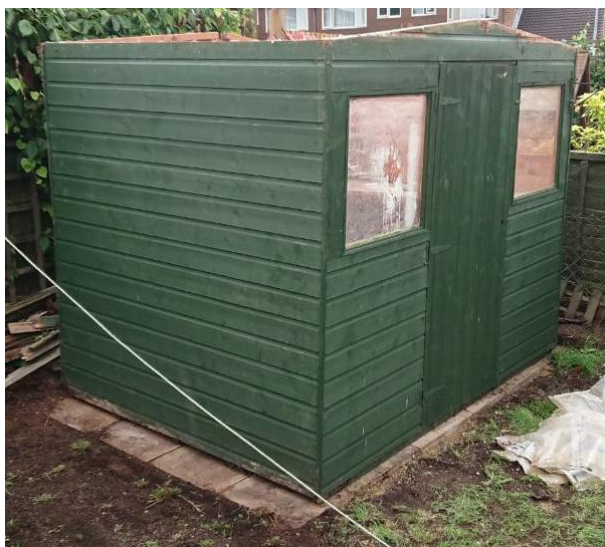
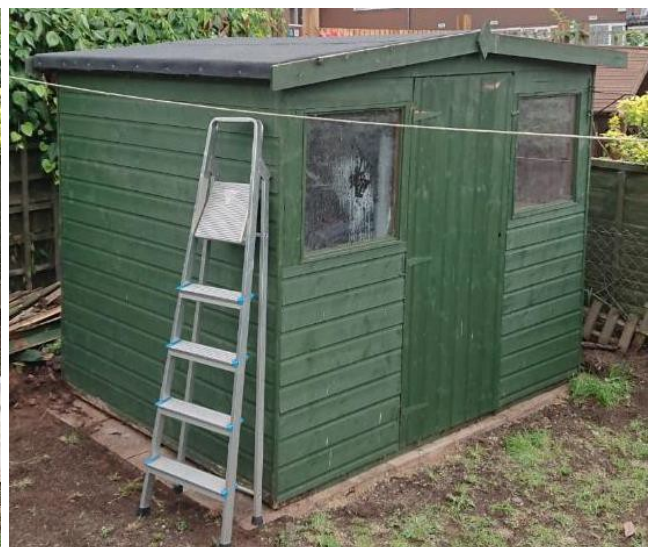
Finally, the roof was refitted and felted with reinforced felt that has a 15-year guarantee. Total cost to the tenant was £46 which included the reinforced felt and six bags of sharp sand for levelling.

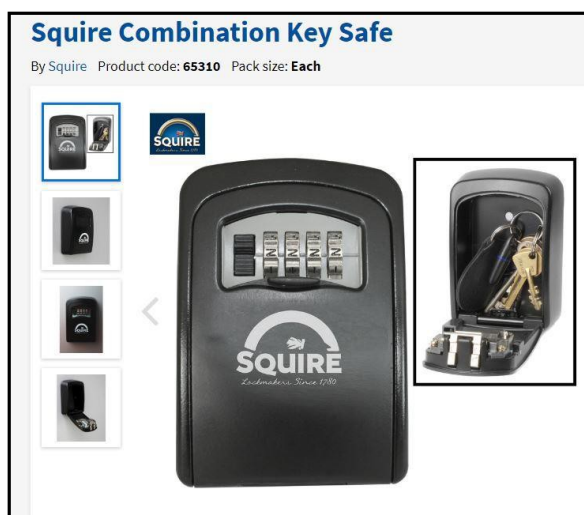
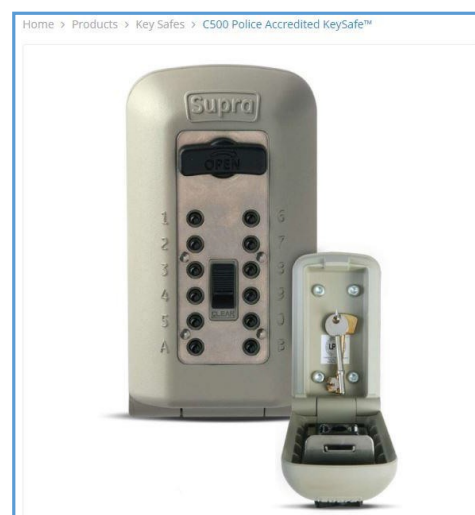
Both key safes are popular and common in their use. One was a combination type, branded as SQUIRE but other brands use this design. The other was a Police Approved Supra C500 keysafe, **this is the keysafe that EFDC, Social Services and ourselves at VAEF supply and fit.**

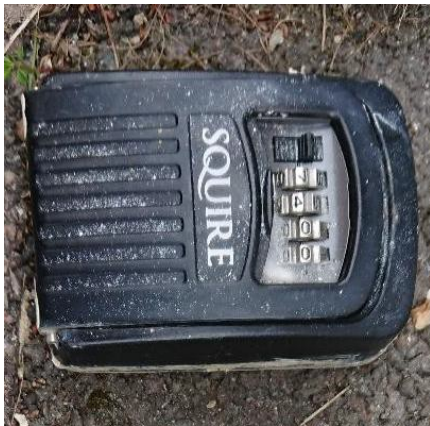
Squire – Combination Type

- 1) I slid a flat screwdriver into the gap where the front closes
- 2) I considered hitting the screwdriver with a hammer but opted to simply pry the front
- 3) The bottom of the casing instantly gave way, allowing the front to fall off
- 4) The back plate (secured by 4 screws in wall plugs) pulled out of the wall with ease

Time to access the contents – UNDER 60 seconds

Noise and disturbance made – NONE

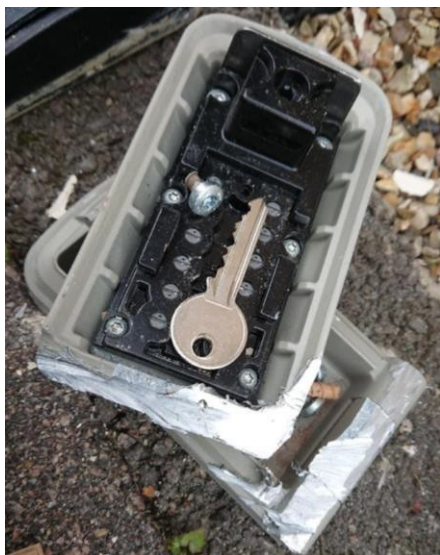
Supra C500 – Police approved

- 1) I could not get a flat screwdriver into the gap where the front closes at all.
- 2) I began hitting the key safe with a 1kg club hammer and chisel (with little impression).
- 3) Next I used an angle grinder and metal cutting disc to the hinge area.
- 4) After almost 20 minutes, with neighbour's interruptions regarding the noise the front came off exposing the key inside
- 5) I could not pry the base plate off the wall at all (secured by 4 x T30 concrete anchors)

Time to access the contents – OVER 20 minutes

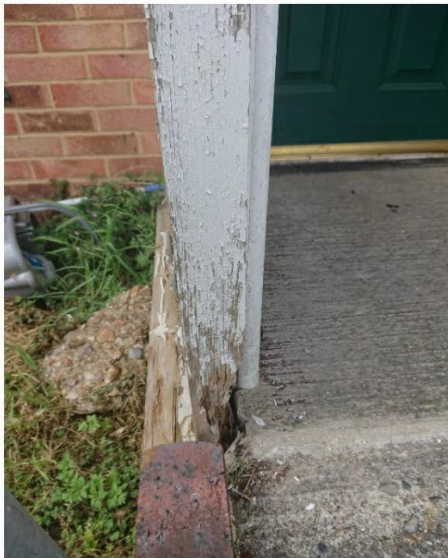
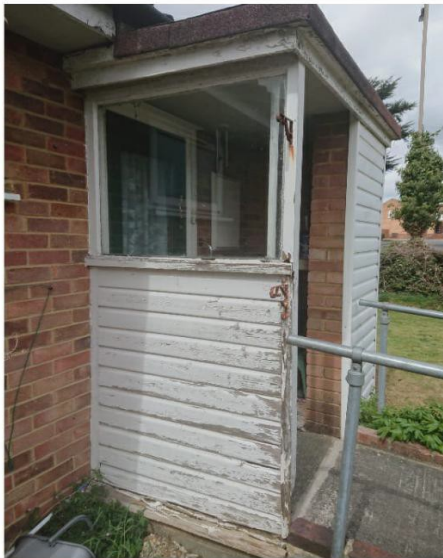
Whilst waiting she would lean upon the side of the porch for support. The EFDC scheme manager had noticed that the porch side was showing its age and had started to rot from the bottom. This rot had significantly weakened the structure to the point that the single glazing was loose and leaked and the side itself was at risk of giving way.

As you can see, the rot was far worse than anticipated which left no option but to remove the side panel for her safety.

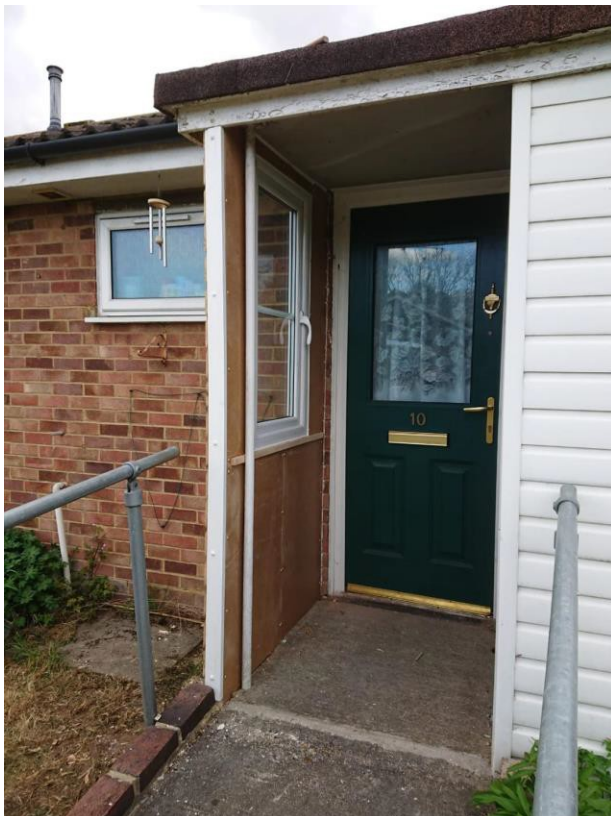
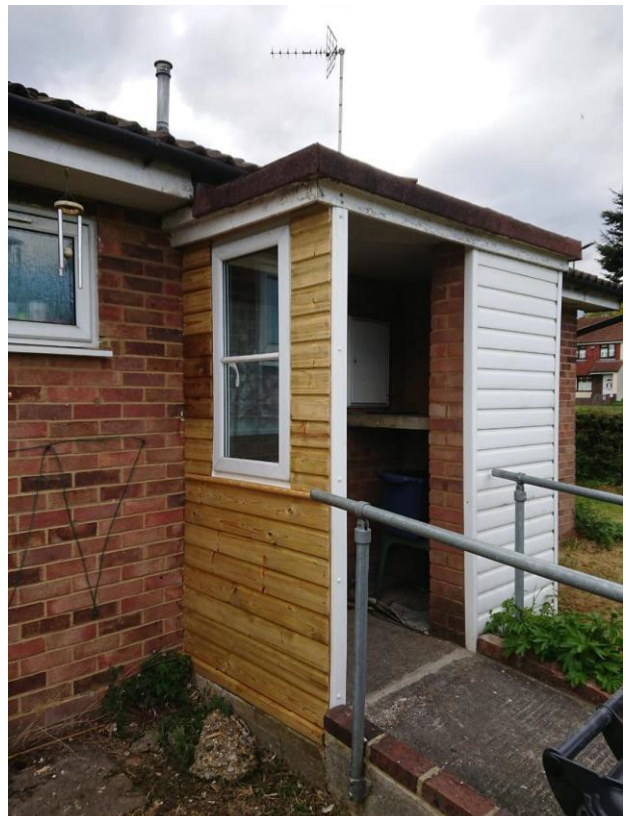
We were fortunate to have the internal boarding and a used UPVC double glazed window donated to the service some time ago which were perfect for this job.

The cladding used had already been treated with an anti-rot preservative and for speed it was finished off with two coats of Danish oil.

The new side is absolutely solid and weather proof looking all the better for its opening and lockable UPVC window. The inside is boarded and the edges sealed.

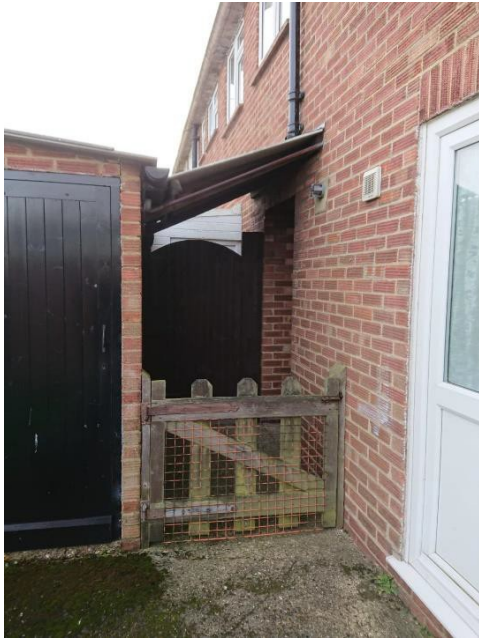
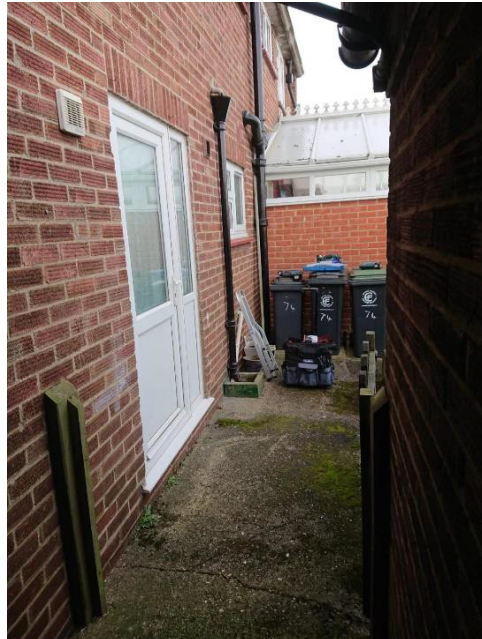
The existing gate was about 3ft high and easily stepped over. Whilst talking about solutions she pointed out her neighbour's taller gate, but remarked that someone could still get over it if they wanted. Clearly we were going to need to provide a stable – unclimbable solution. We also agreed to fit a sensor light to illuminate the dark alley (which was dark both day and night).

A very sturdy frame was built using 75mm x 75mm treated timber. This was bolted to the wall each side using recessed M10 concrete through bolts as anchors.

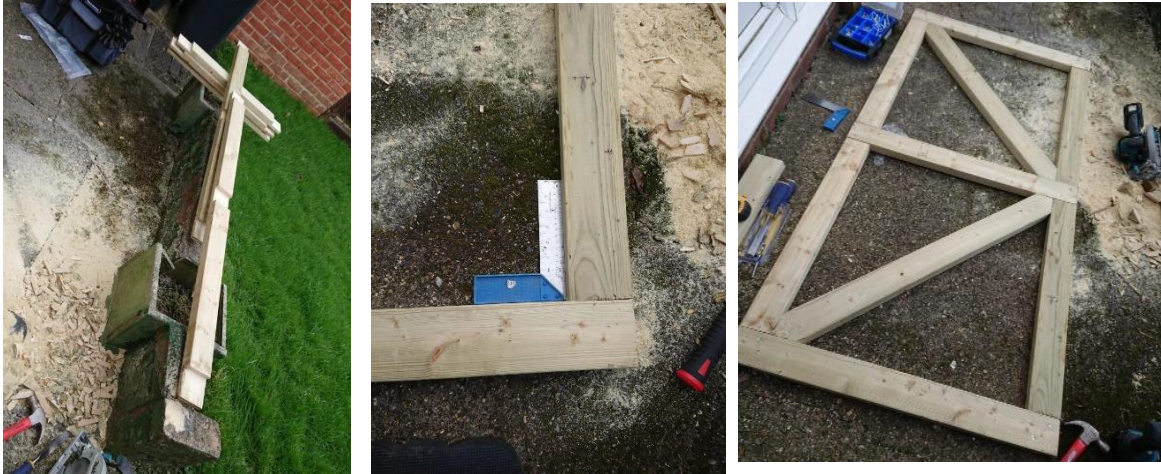
The only option was for us to build a fully bespoke gate. The gate we built was made from heavier gauge timber than the “shop” one and was also fully framed, ledged and braced using half lap joints and hardware. Time was taken you ensure the gate was square and very strong. All timber was fully pressure treated with preservatives to enhance resistance to rot and insect attack

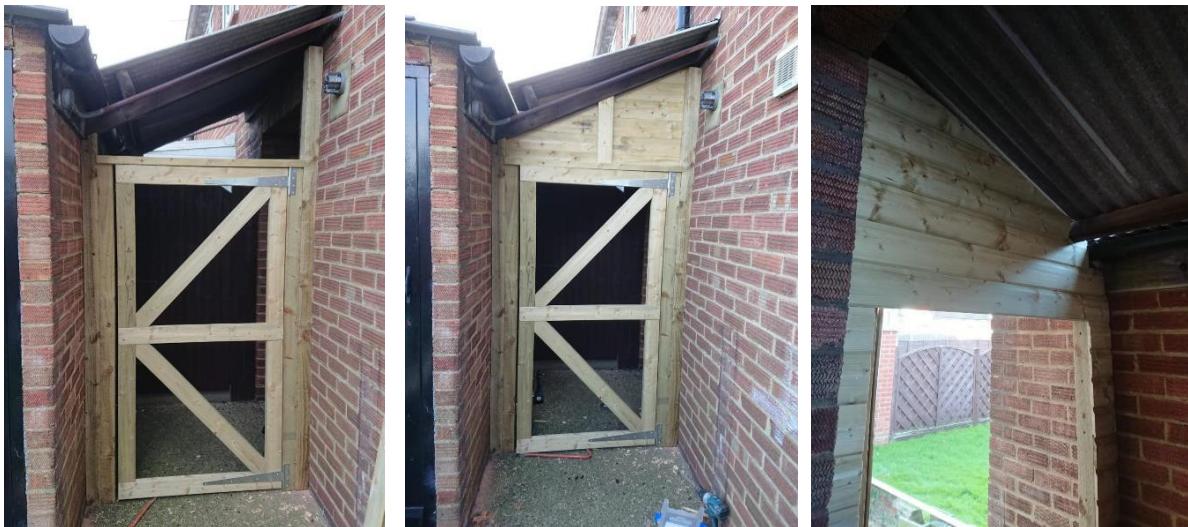
Using the existing pent roof as the top of our frame we could infill with exterior timber cladding ensuring there was no access point available by climbing the gate.

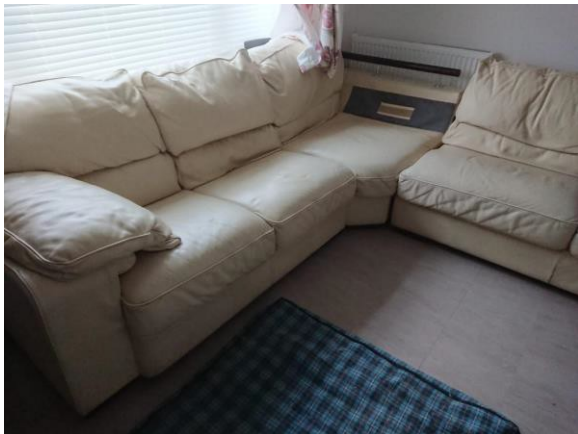
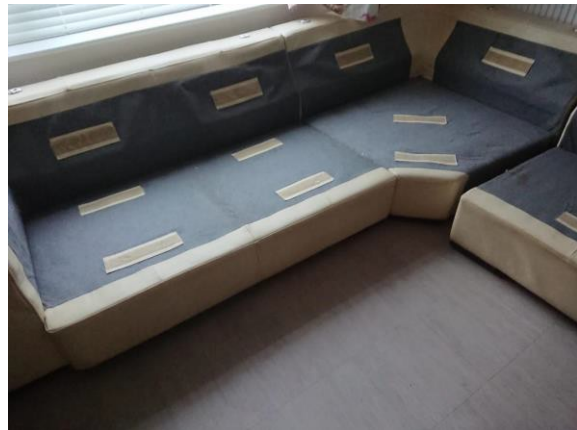
The actual feet on the unit were only about 40mm high and as you can see the whole thing really was quite low.

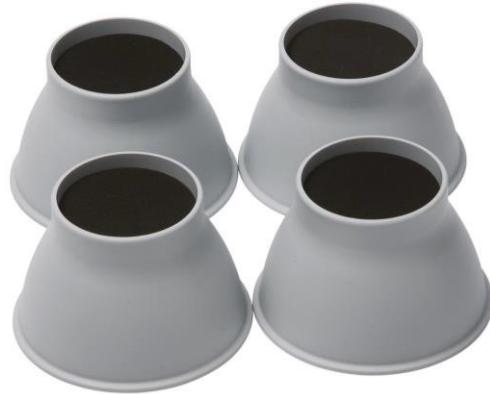
I have always had an issue with some traditional types of chair raisers, because they are so ugly and obvious. I've often had discussions with clients about how solutions can be found to assist them with their mobility issues without advertising it to everyone and creating an eyesore in their living room. Below are some of the typical "in your face" products available.

In this case the corner unit split into three sections, two settees and one corner. If it been raised using the black adjustable product above the material cost would have been in the region of £156 as three sets would be required.

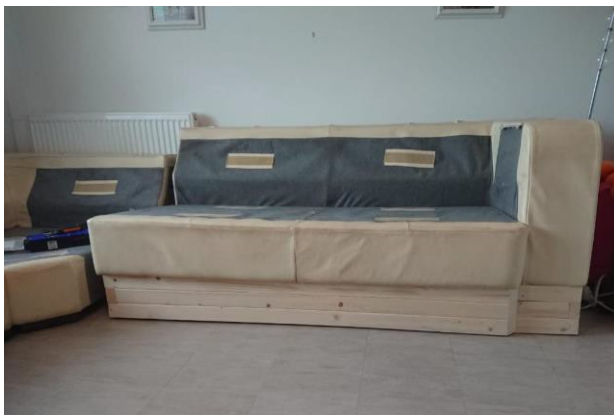
You can see from this picture the height difference between the settee and the corner unit

I felt that this was an example of where the solution "could" be practical, economical and aesthetically pleasing. I decided to build a frame of planed timber which would provide an even and secure base affixed to the unit. The client asked for a 150mm increase in height in addition to the original foot height of 40mm – this solution provided a height of 189mm.

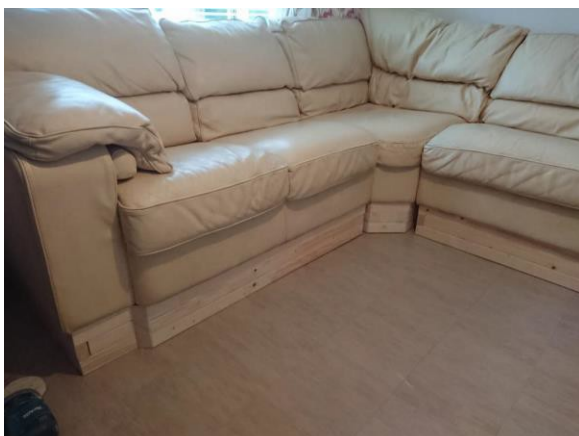
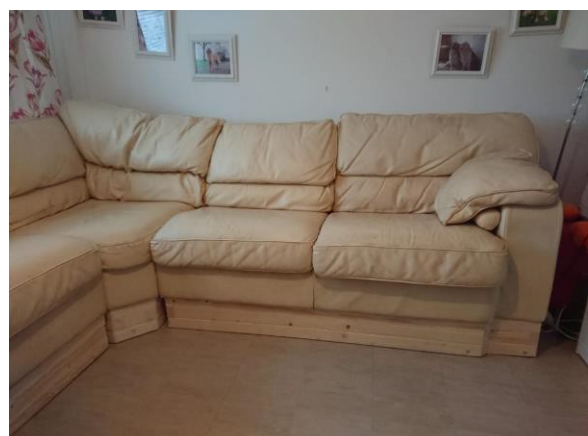
Below with cushions replaced

There was an added bonus with this “fix”. The tenant has a guide dog and often it moulted hair accumulates under the furniture which they found difficult to clean – but no longer!

The finished item actually looks even better than the pictures with the natural wood complimenting the cream leather. Most importantly the new seating height is absolutely perfect for the couple who can now get up from their comfy corner sofa in safety and with relative ease.

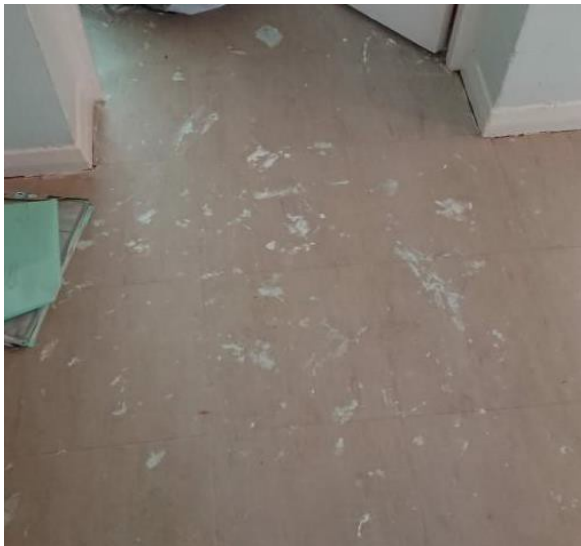
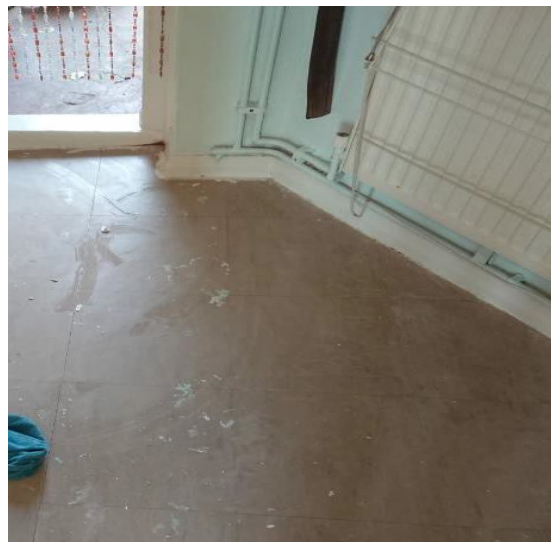
When I arrived Mrs W was extremely anxious, concerned that I would judge her badly due to the “state” of the flat. As is often the case, a cup of tea and a chat calmed her and uncovered the story behind the situation. Mrs W had paid someone almost £300 to decorate her hallway. When she described this person's behaviour I couldn't believe how badly she had been treated. The walls, ceiling, doors and skirting had been painted, however there was absolutely no prep work done, nor was anything masked or covered.

The entire floor was covered with paint; the pictures below are after an hour's cleaning.

Unable to make real headway with the clean-up we discussed low cost alternatives and decided upon some self-adhesive vinyl tiles from Wickes.

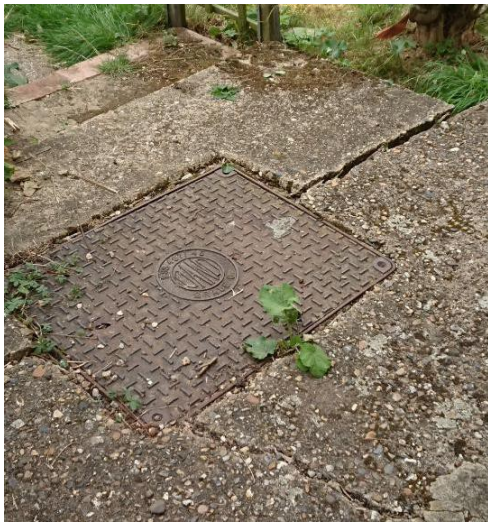
My first observations:

Multiple cracks, holes, weeds and moss – so much moss

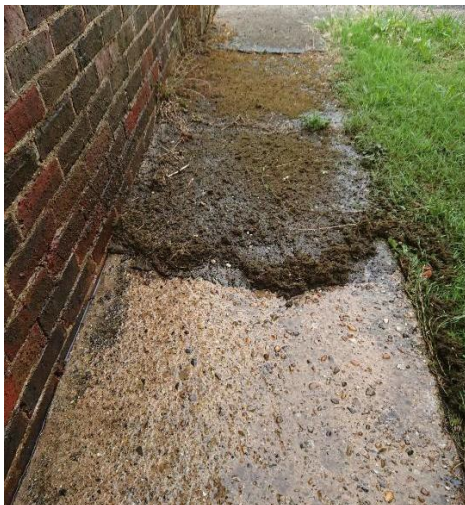
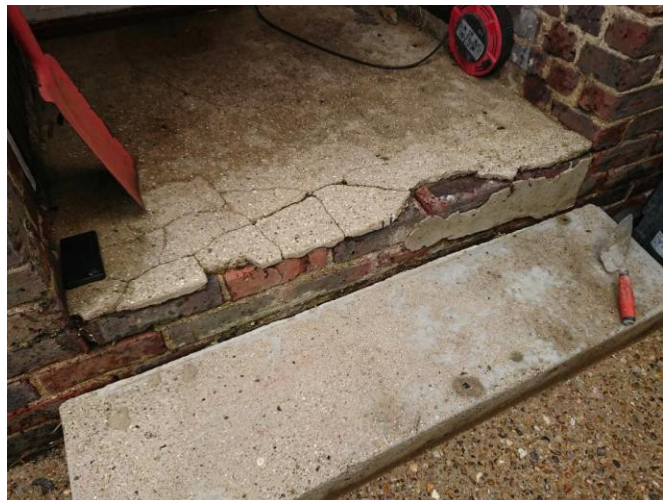
Power washing exposed the extent of the problem and revealed the very dangerous, crumbling step.

I used quickset concrete with Sovereign SBR Bonding Agent to ensure long term adhesion to the surrounding area. Whilst I was unable to fully level the area I was able to build gradual sloping repairs which removed the physical trip hazard.

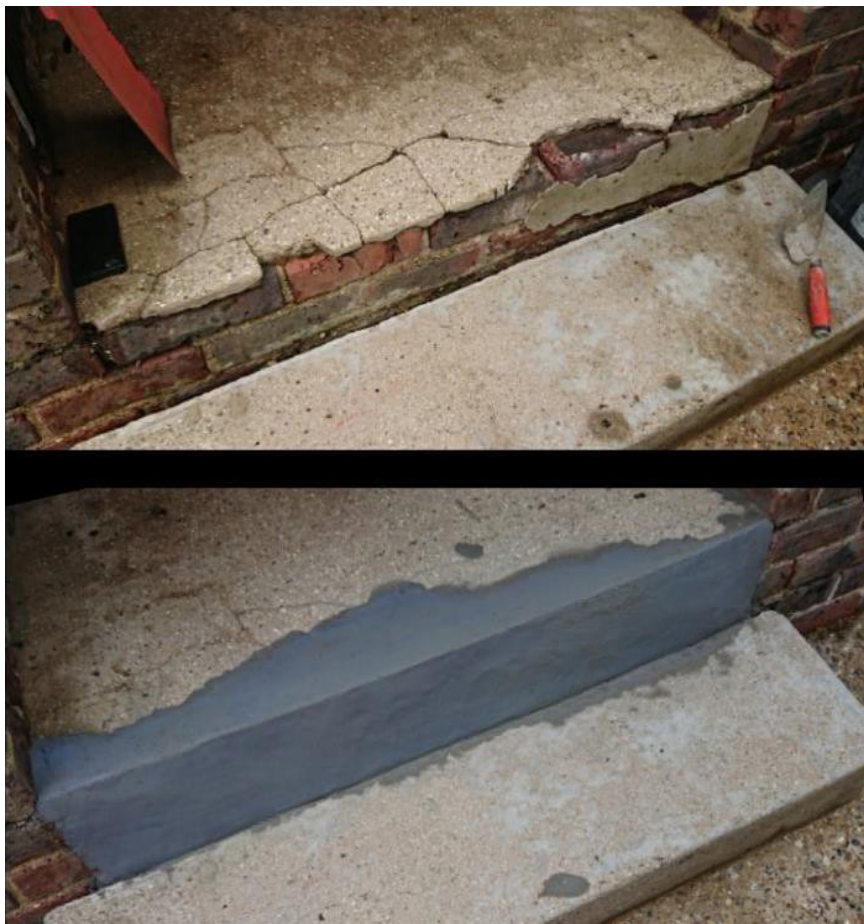
So, remember the step? (it will dry grey!)

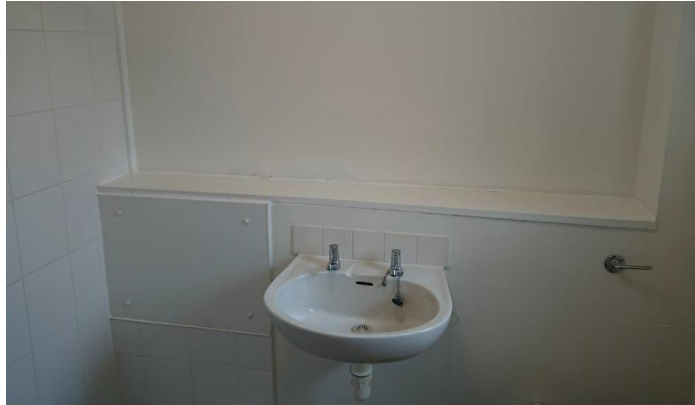
Prior to Mrs Y moving in, 15 years ago, one wall had been boxed-in around the sink and toilet with the lid on top heavily coated with gloss paint. There were some small yellowing tiles over the sink and the wall simply painted.

The top of the boxing in was fixed, providing no access to the pipework behind for the toilet and sink. So part of the improvement would be to address this by providing a removable cover.

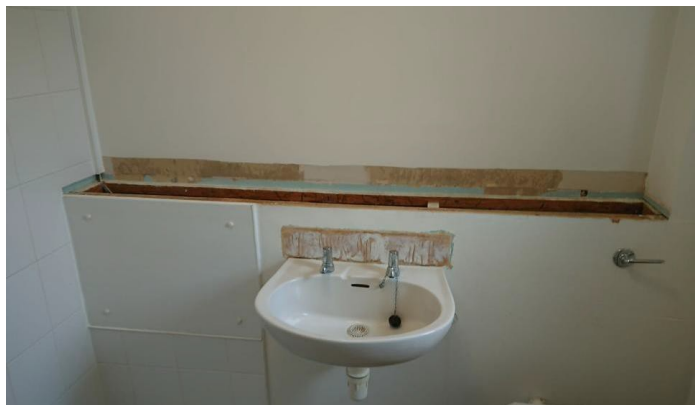
Sadly, removing the top cover took some of the wallpaper with it.

I decided to use white UPVC fascia board for the lid. This is extremely light weight, and fantastically easy to clean. Once cut correctly just two capped screws would be required to hold it in place until such time as maintenance or repairs are required.

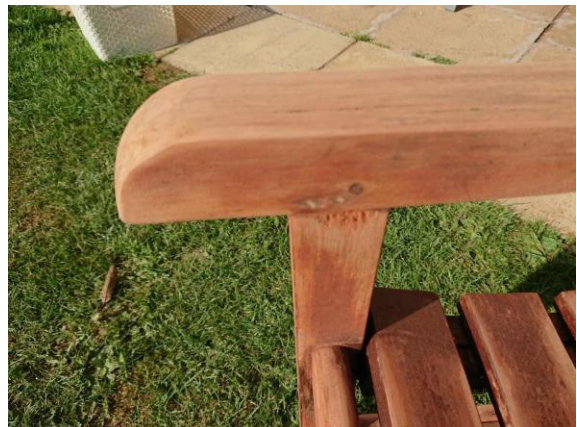
The damage

Stripping away the surface uncovered some damage but it was not as bad as I had feared:

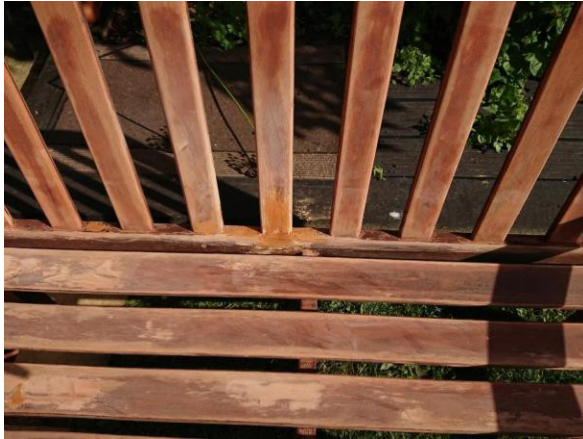
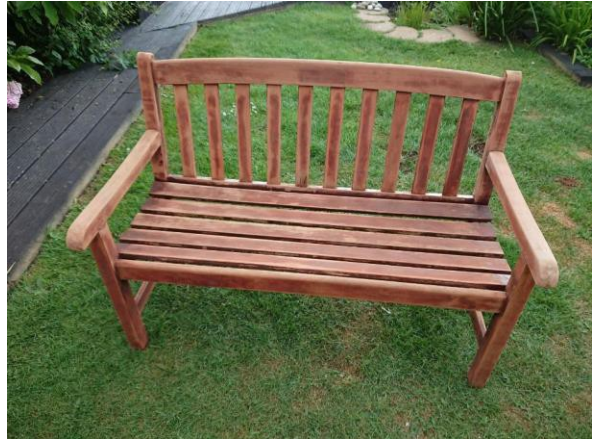
Filled, repaired and multiple sanding's

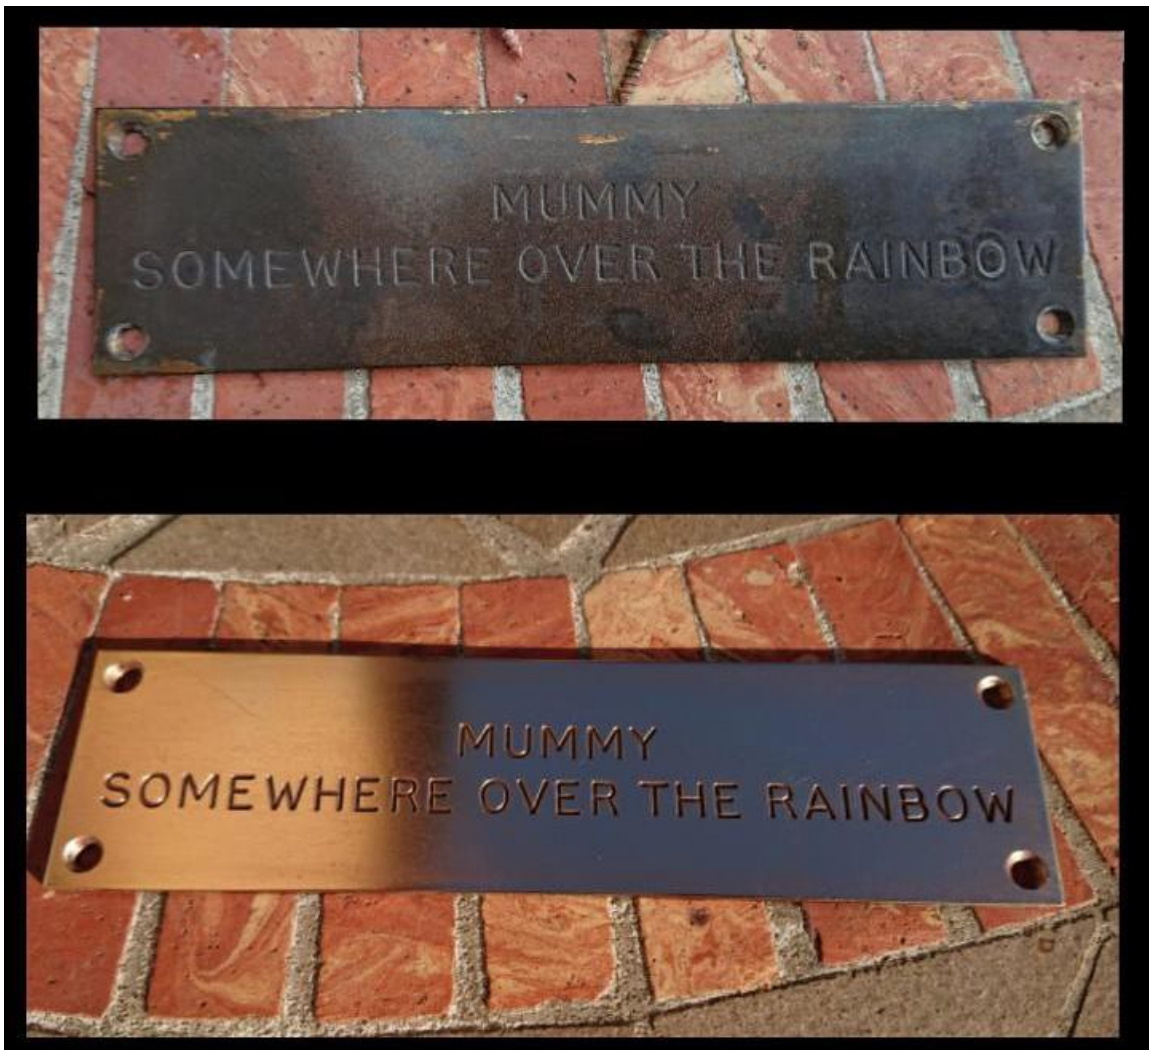
The Plaque:

With no “Brasso” available I turned to a “google” home remedy and put the tarnished plaque into a small container and covered it with “tomato ketchup” for 45 minutes – Mrs B thought this hilarious when I told her – but it worked

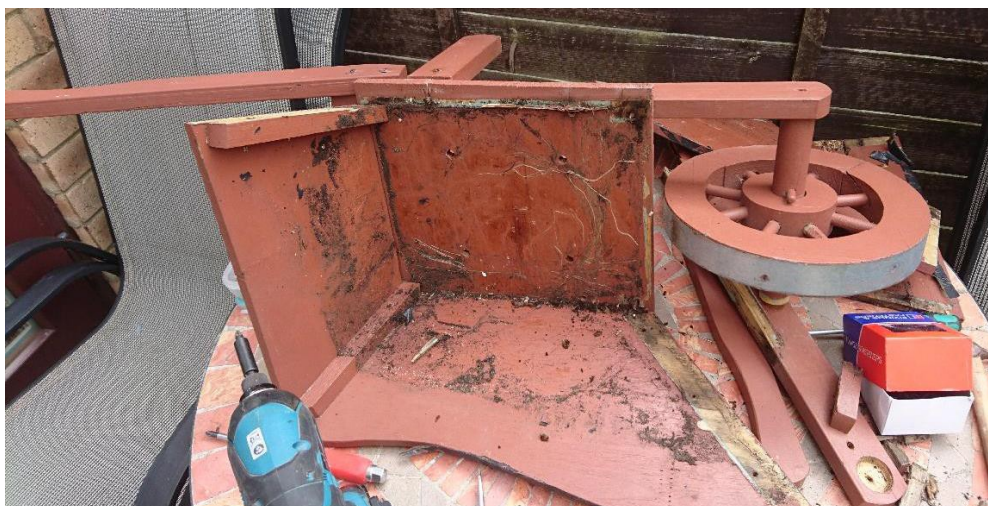
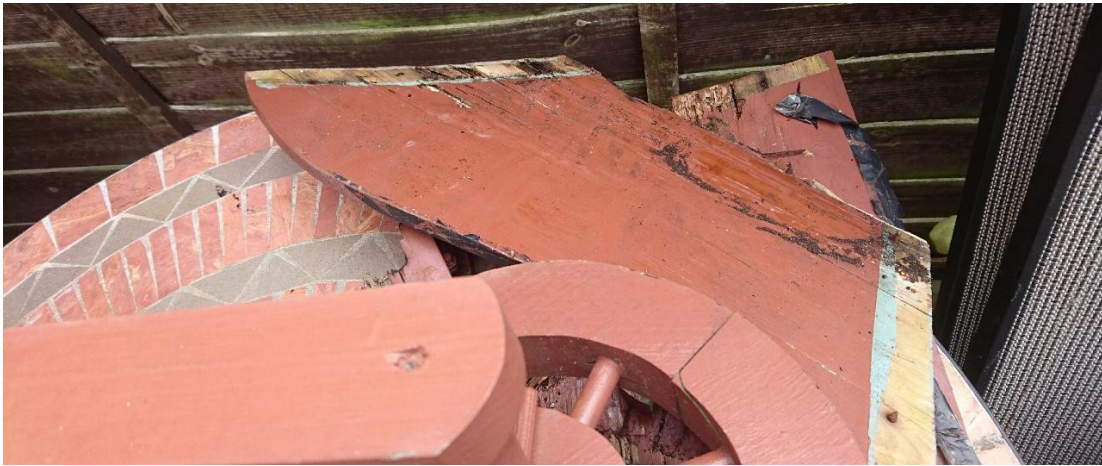
Taking it apart revealed extensive rot:

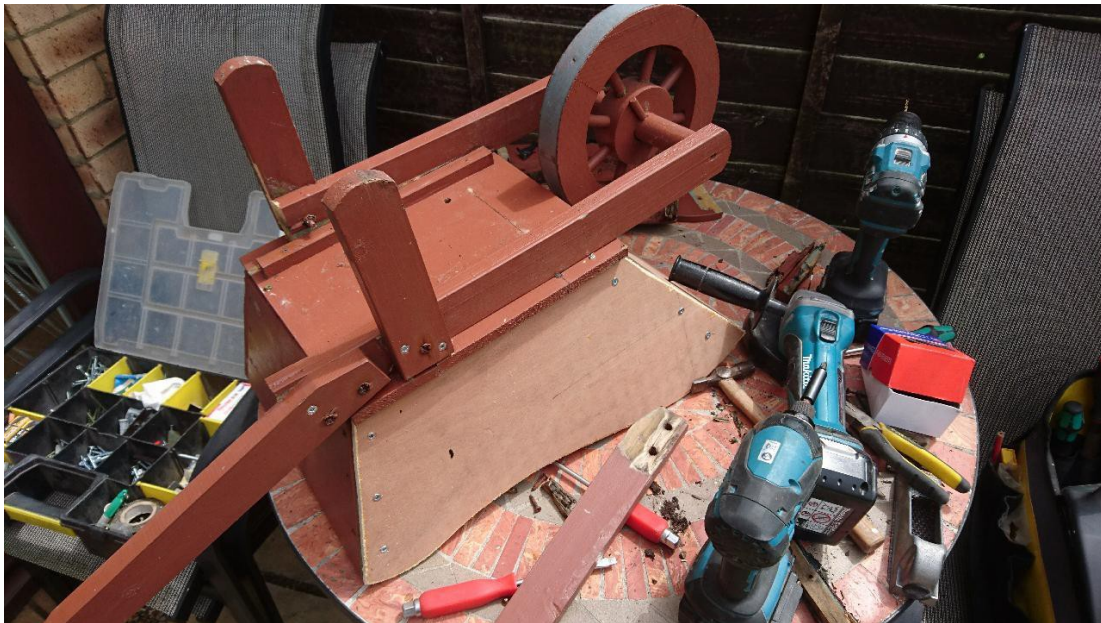
Using some scrap wood and the old parts as templates I started to rebuild:

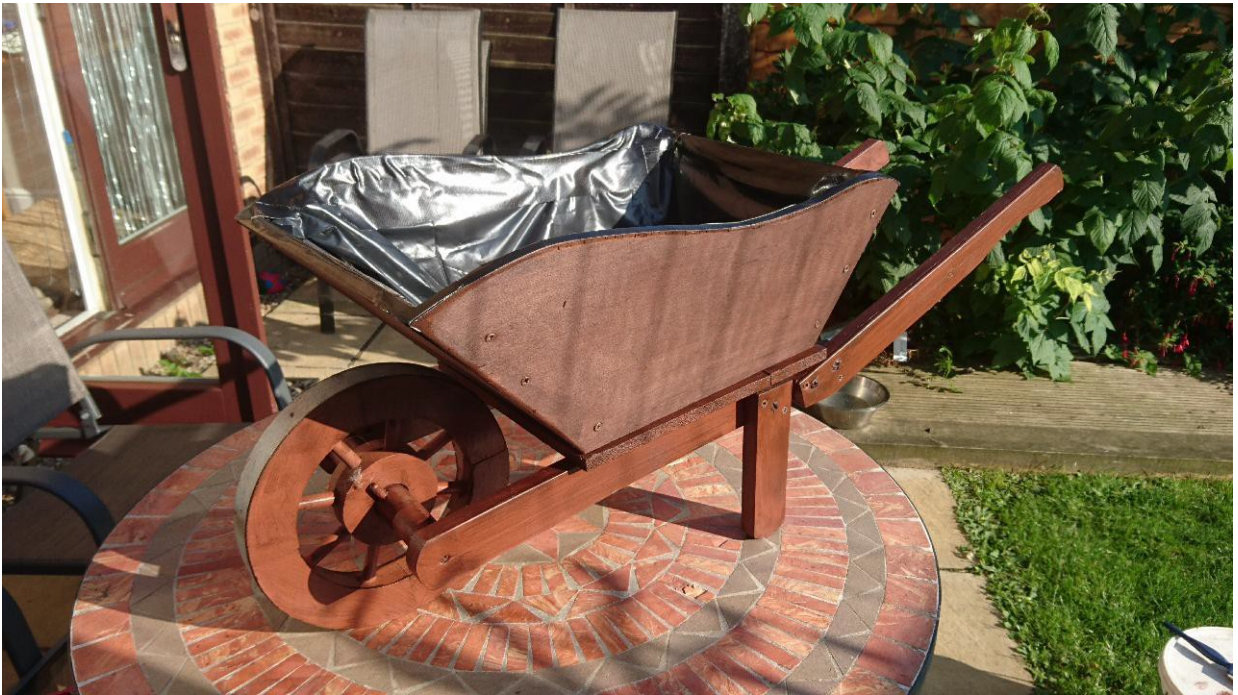
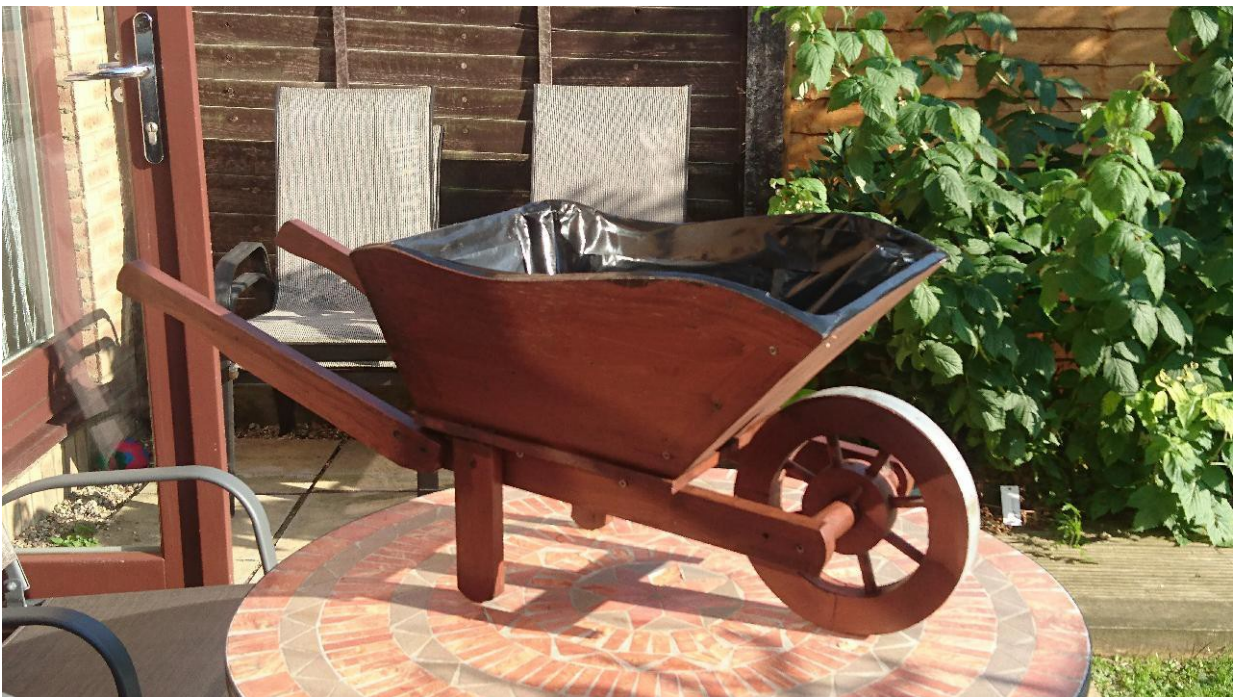
Finally, by replacing the liner and a few coats of preservative its fixed

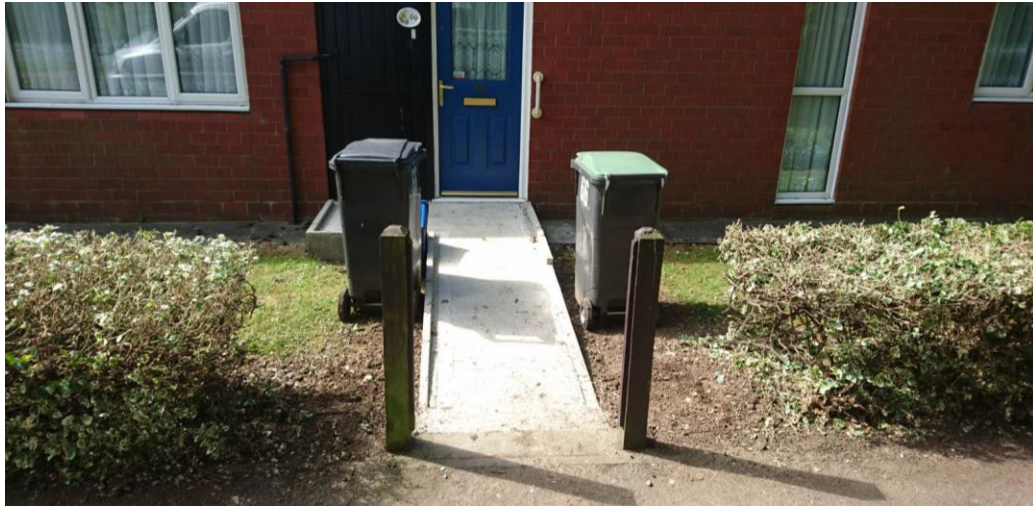
- 1) The inward opening gate – Mrs B uses a frame so whilst on the new incline it is impossible for her to pull the gate open and step back to get past it. A small lip around the perimeter of the ramp created a trip hazard of its own.
- 2) The two wheelie bins were now situated to one side of the ramp, Mrs B could no longer get to these or have any chance of heaving them up over the lip and onto the ramp to put the bins out.

As you can see from the picture, EFDC Estates did an excellent and very rapid job cutting back the hedge.
