VOLUNTARY ACTION EPPING FOREST

HANDYMAN

Case Study - VAEF Handyman Service – Building a Yacht!

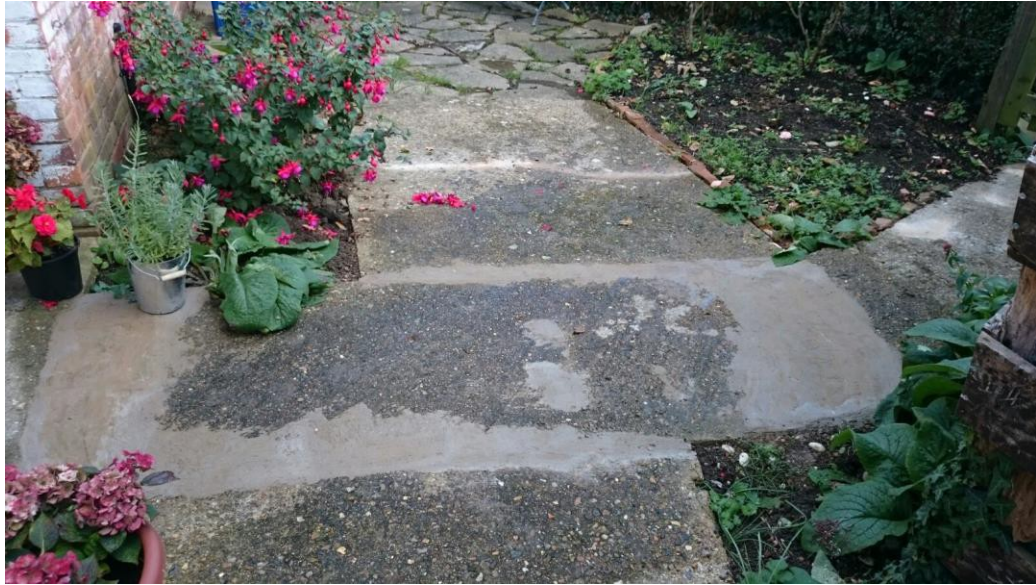
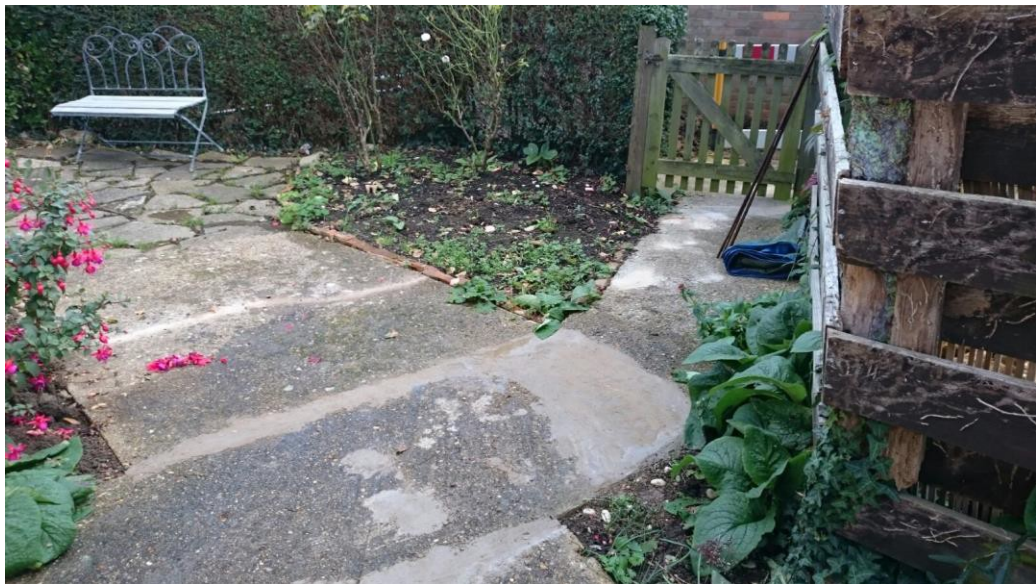
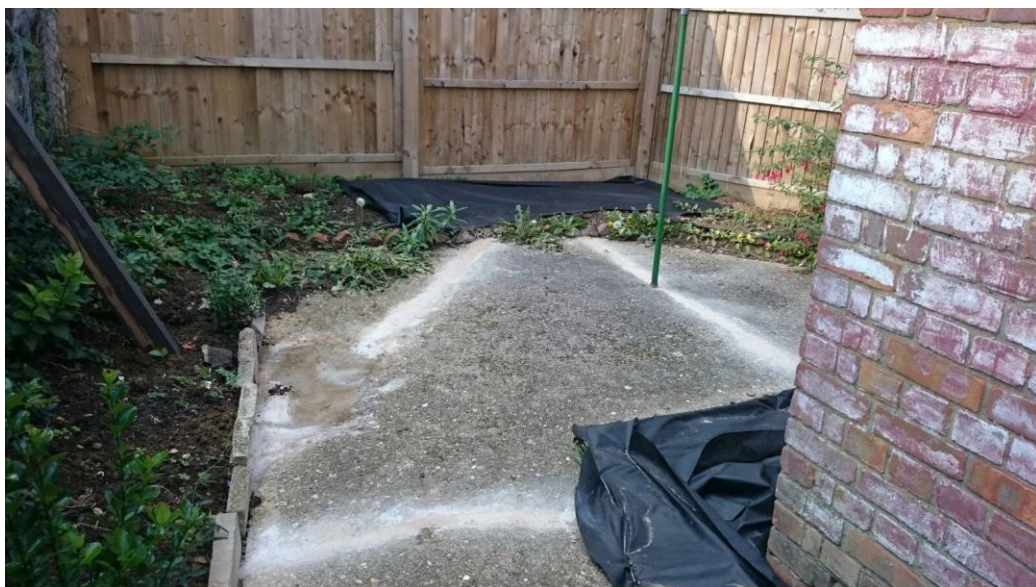
Mrs W had a nasty trip in her garden caused by the very uneven path. Over time the path has become uneven and in places levels differed by up to 30mm, easily enough to create a trip hazard.

An additional visit is planned for the spring to attend to the crazy paved area, until then the tenant knows to avoid this hazard.

The cost of materials was under £18 and the client said she felt far more confident of being able to walk safely around her garden.

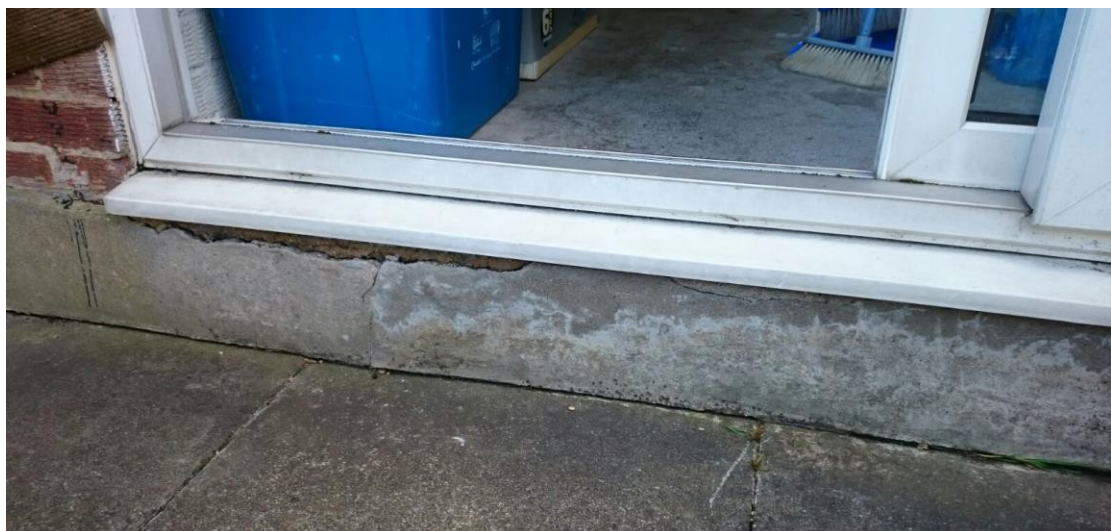
The existing step was approximately 300mm high including the door frame.

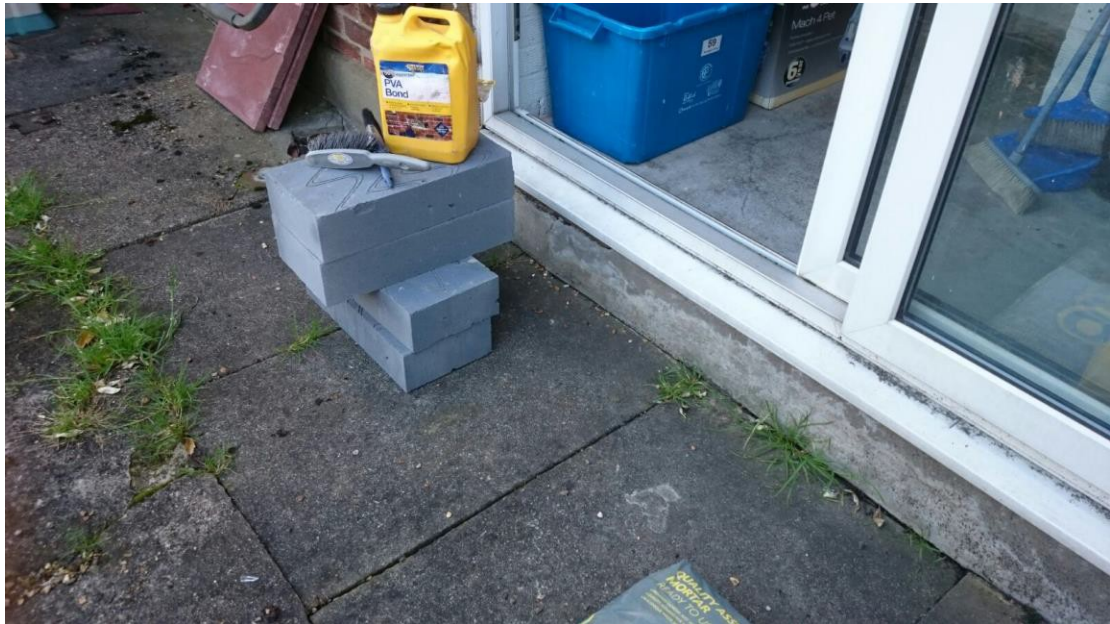
Initially Mr M requested that a handrail he had purchased could be mounted by his back door so that he could negotiate the back door step safely, however it was very clear when I visited that the step itself was a risk due to its height. Mr M had hoped to "find" some paving slabs and create a small step by laying them loosely upon each other. This of course would present another hazard as they would not be secure or steady.

We agreed that I would build a step using rendered breeze block, cement / pva bonded and capped off with paving halving the existing step height and providing a 450mm x 900mm safe and secure half step.

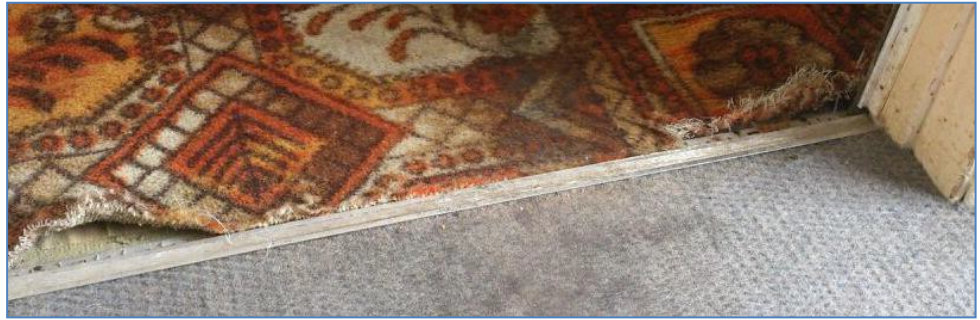
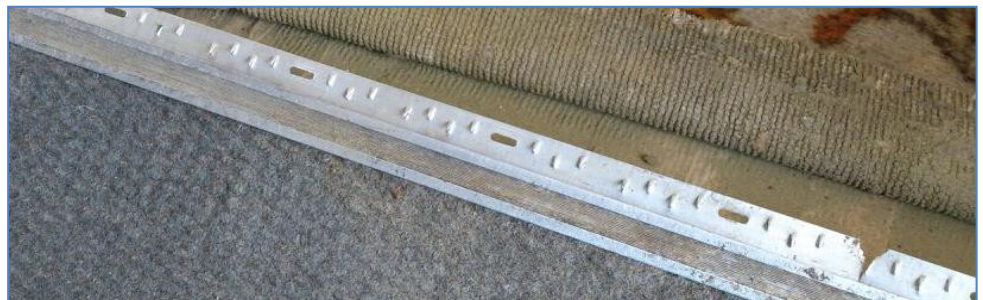
As well as the rucked up carpet the bar itself was now raised and loose.
